**CONSTGLASS**

**Conservation materials for stained glass windows – assessment of treatments, studies on reversibility and performance of innovative restoration strategies and products**

**Final object report**

Canterbury Cathedral (England)

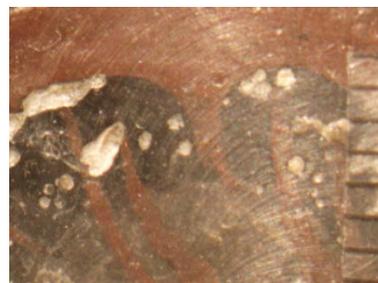
Wax application in 1984

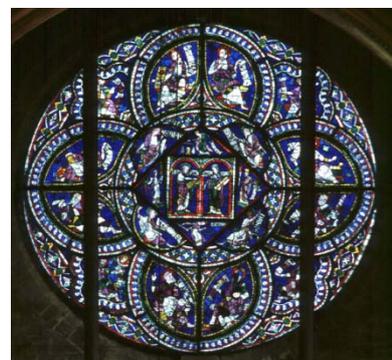
Window NXVII

The North Oculus window NXVII is a late 12<sup>th</sup> century window depicting the Old Covenant. It is at clerestory level and faces due north.

In the late 1980s wax was applied in situ onto uncleaned flaking painted decoration. The window remained without protective glazing until 1992, when the glass was taken to the studio for conservation.

The wax was found to have de-laminated and become brittle in many places, while in other places it seemed to adhere well to the substrate. It had also darkened and gathered dust. It was therefore decided to remove the loose areas of wax with a scalpel, and to thin down well adhering areas by shaving off the excess. The loose and fragile painted decoration was then consolidated with Paraloid® B72 ca

7% in acetone, often on top of a remaining wax layer.

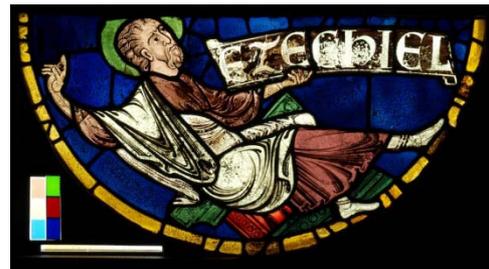
Panel NXVII C2

NXVII, condition in 1992, and re-treated area, acrylic resin on artificial wax

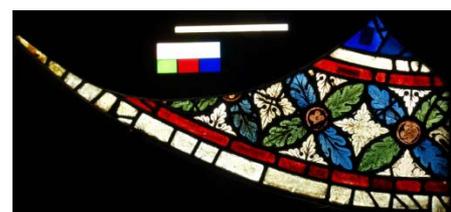
Panel NXVII C1

Also in 1992, a trial application of SZA and Ormocer® was carried out on panel C1.

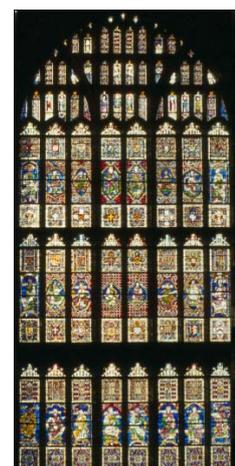
In July 2009, a stone fall raised structural concerns which made the removal of the medieval stained glass from the Great South Window SXXVIII necessary. Several panels showed the application of polymer coatings both internally and externally. There was no documentary evidence for this application, but correspondence between Professor Newton and Frederic Cole indicates that the use of Viacryl® was discussed for this window. The window was set into an externally ventilated protective glazing system, which was found during the de-installation in 2009 to have significant failures, with a very small interspace and signs of water penetration onto the historic glass. The consortium decided to include the identification of the polymer in the CONSTGLASS project.

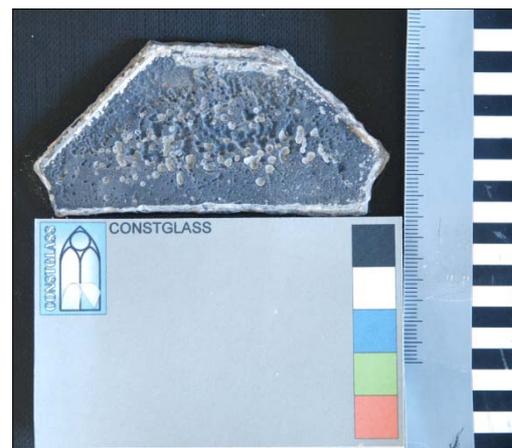
Panel SXXVIII A16, decayed polymer coating on original sample

The polymer coatings found on panels at the apex of window SXXVIII showed a wide range of phenomena. They were used internally to consolidate paint decoration and externally as an overall coating. The internal application was found to be in perfectly sound condition, whereas the external coatings varied in appearance from near perfectly preserved to laminating to only remaining in some corrosion pits.

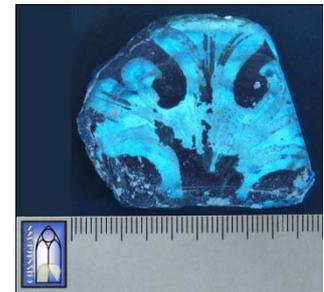
Two samples of 13<sup>th</sup> century glass coated with wax were removed from nII 7 and sent to Ghent University and Sincrotrone Trieste. The extreme thinness of the wax application made visualisation difficult, but no de-lamination between coating and substrate was detected.

Panel nII 7, original glass samples and coloured optical coherence tomography scan of a section, showing wax coating (in red)

Doped 'dummy' samples, and phase contrast computer tomography image of interface in section

target. In addition to that, the materials were doped with umber pigment, on one set the wax, on another the acrylic resin, to create a visible contrast between the two materials. The results were surprising, in that no clear division between the two coatings was visible, indicating that a) the adhesion was excellent, and b) that there may even be a degree of interdiffusion between acrylic resin and wax. The agent for this possible interdiffusion would be the acetone in which Paraloid® B72 was dissolved.

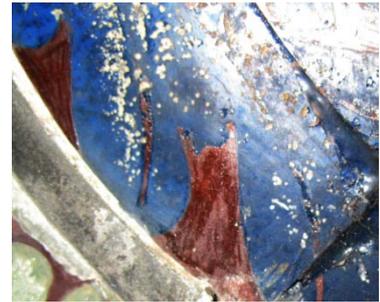
Panel sVII 1, silicone edge-bonding, 1984

In the context of CONSTGLASS, the performance of silicone bonds was examined via light microscopy on all pilot objects. All bonds were found to be stable and in good condition, and no colour change was observed. There were no visible signs of lead deterioration associated with silicone.

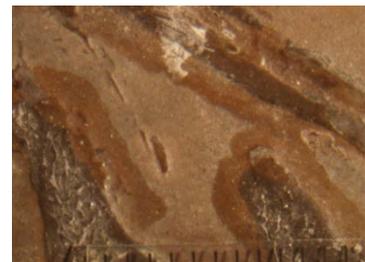
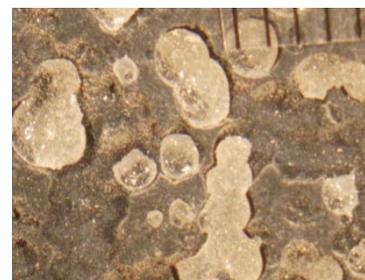
SEM observation revealed microcracks, delamination, loss of transparency and discoloration in the externally applied coating. No detachment of glass surface was observed where the coating had delaminated from the glass surface.

SXXVIII, different states of preservation of polymer coating

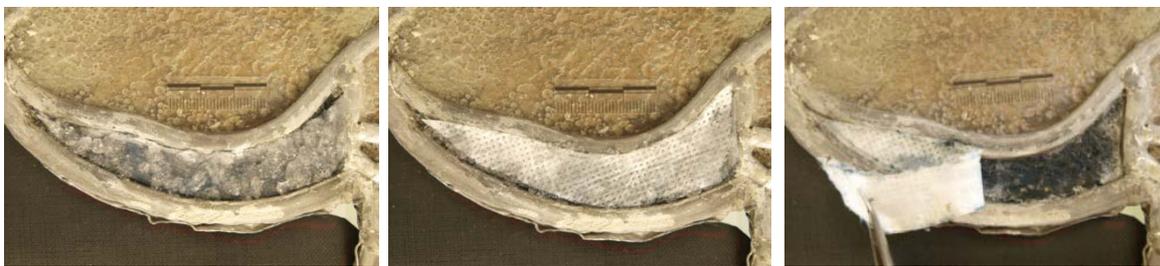
Panel SXXVIII C1, reversibility test

Two of the studio's conservators took part in the reversibility workshop at Artesis University College in Antwerp. The knowledge gained during this workshop was then applied to carry out reversibility tests on two pilot objects, sVII (wax) and SXXVIII (polymer). The tests showed that the coatings can be removed safely, with dichloromethane swabs in the case of wax, with ethanol gel in the case of the polymer, the risk analysis showed that removal of the coatings found on any of the pilot objects was not necessary. The wax coatings were in sound condition and were not giving reasons for concern. The polymers were either in reasonable condition, or were so decayed that they could be left to fall off in their own time.
